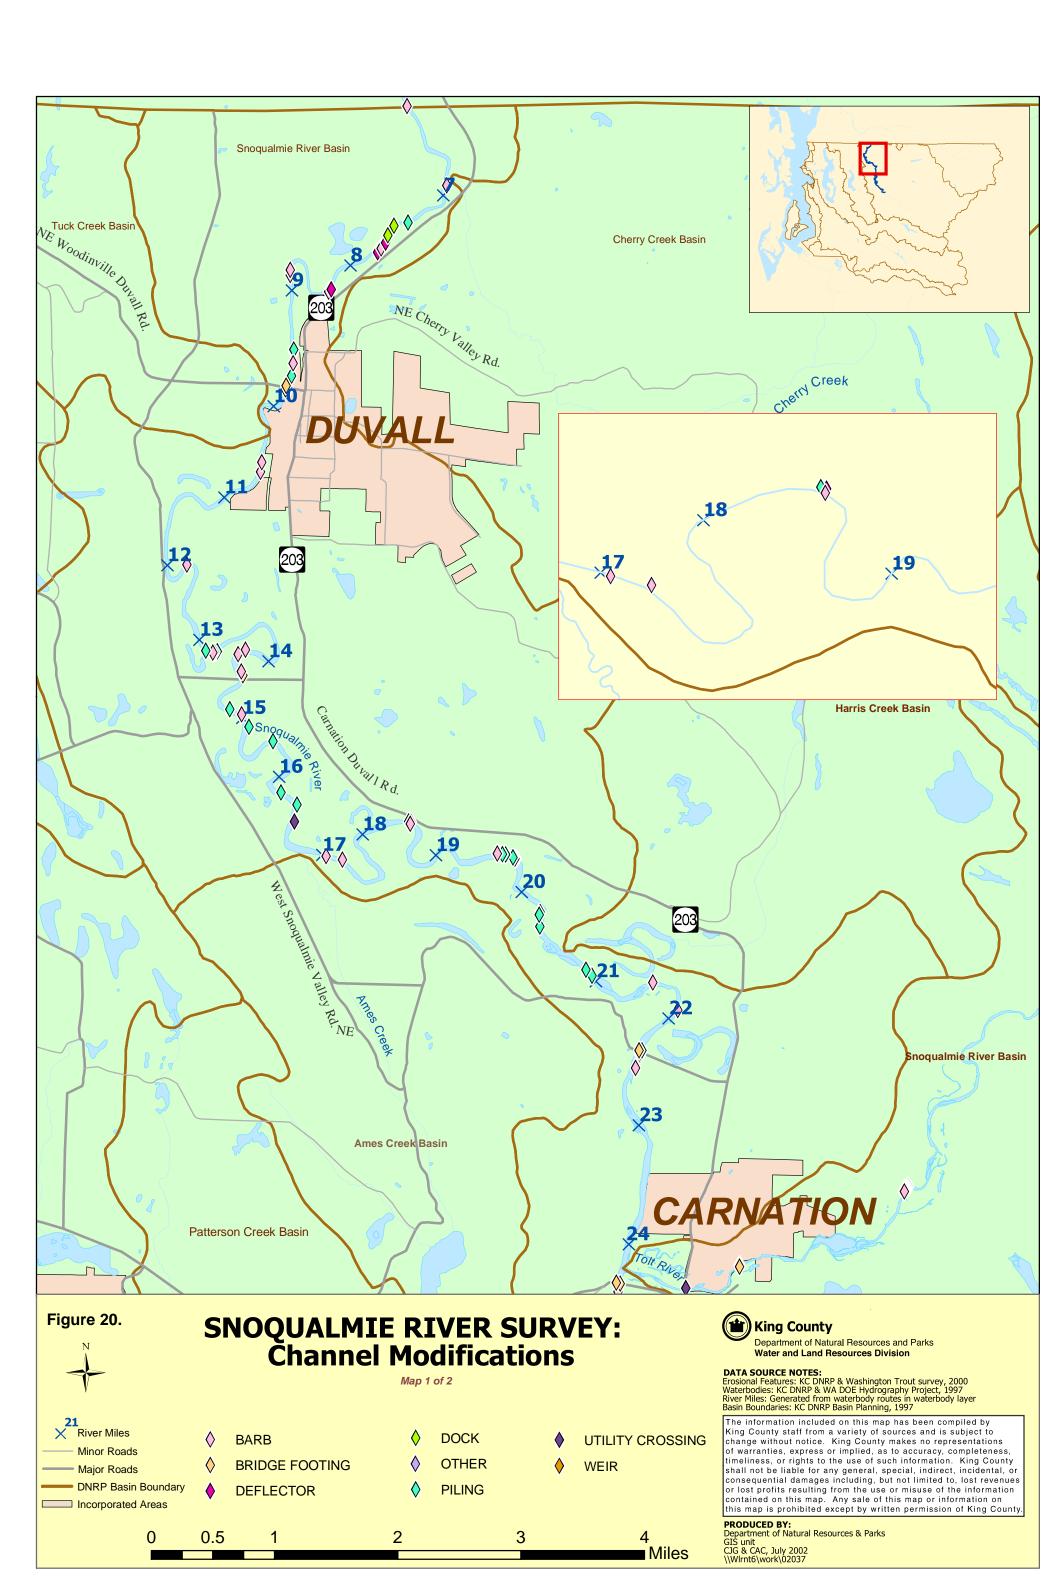
Figures 20 and 21 show the locations of channel modifications including barbs, bridge footings, flow deflectors, docks, wooden pilings, utility crossings, and weirs. Barbs are riprap features that are designed to deflect flow away from a bank. Pilings are the remains of old docks that were used in historic boat transportation on the Snoqualmie River. By nailing boards parallel to the river flow, these pilings also function like bank armoring. Barbs and pilings were the most frequently noted structures. Thirty-six barbs were mapped; they were evenly distributed throughout the study area. Forty-six areas of pilings were observed, with the largest concentrations occurring between RM 11-19 and RM 29-38. Docks were observed only at RM 7.5; human access by foot and boat are also indicated at this location (Figure 20).

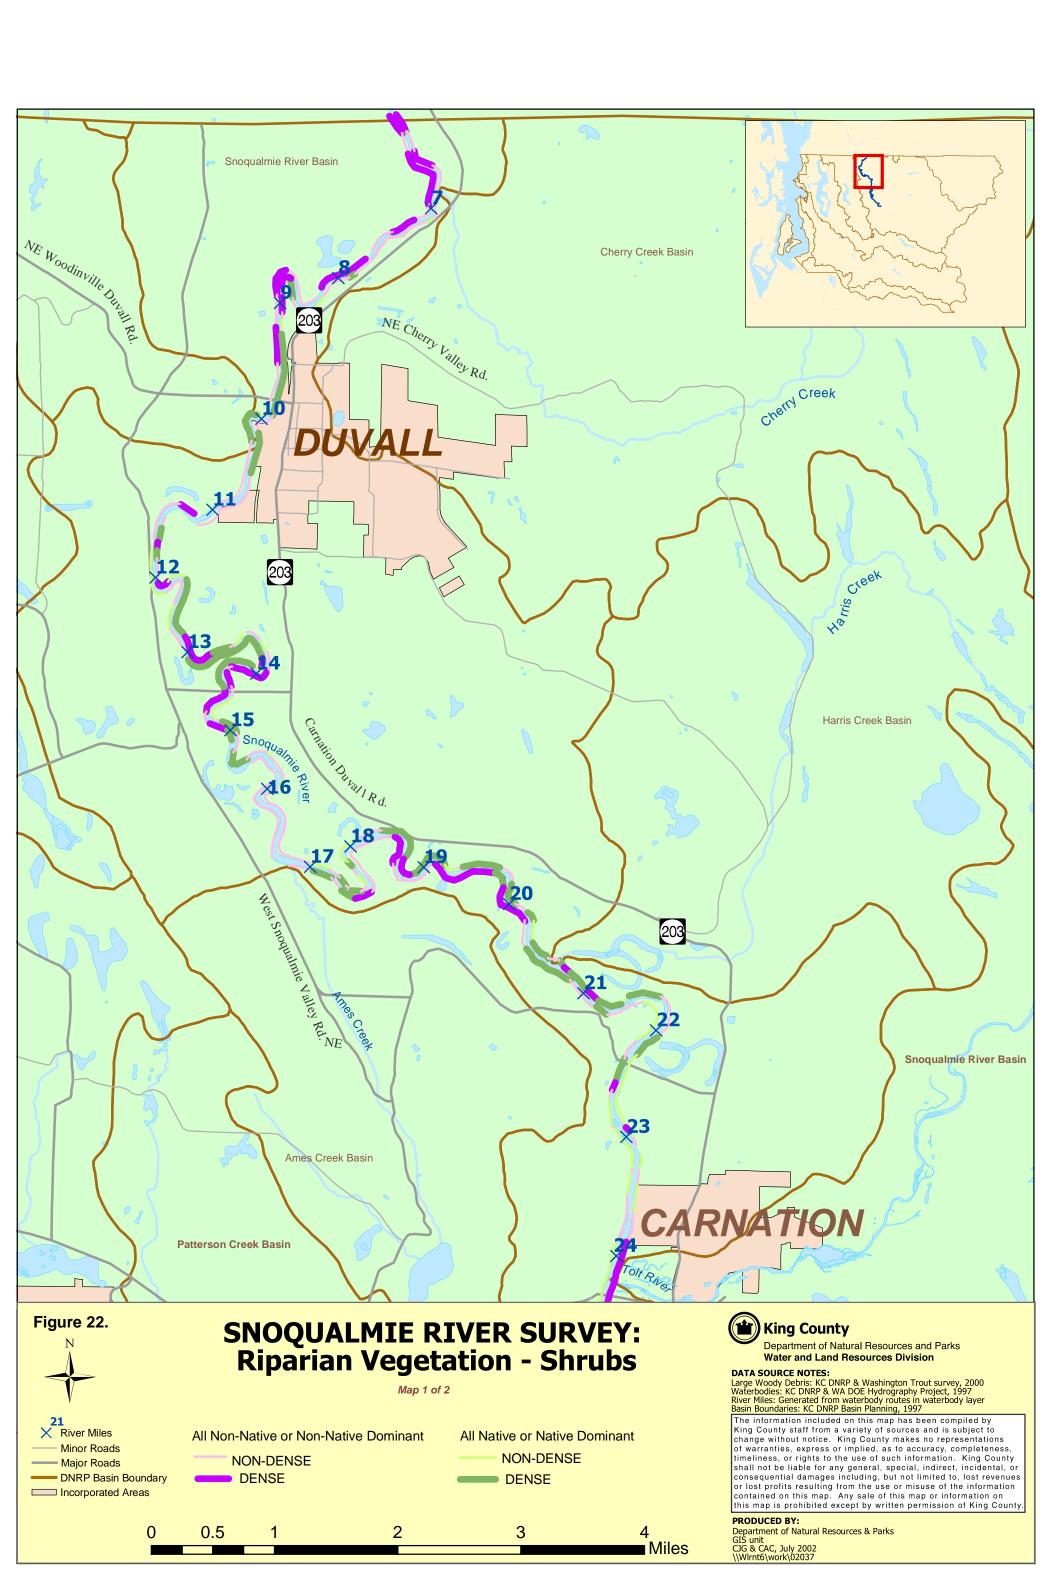
Figures 22 to 25 show the location, types, and density of riparian shrubs and riparian trees that were growing on the banks of the Snoqualmie River downstream of Snoqualmie Falls in the summer of 2000 and could be seen from the boats during the habitat conditions inventory. The designation of "non-dense" indicates low or moderate density of the vegetation. The designation of "non-dense" indicates low or moderate density of the vegetation. Several shrub species that are not native to the Pacific Northwest were observed throughout the length of the survey. Of these, Himalayan blackberry (*Rubus discolor*), Japanese knotweed (*Polygonum cuspidatum*), and virgin's bauer (*Clematis spp.*) were prolific. Other invasive species included English ivy (*Hedera spp.*), butterfly bush (*Buddleia davidii*), and yellow tansy (*Tanacetum vulgare*), which is poisonous to livestock if ingested. Purple loosestrife (*Lythrum salicaria*), a very aggressive, nonnative species, was observed in a few locations in the reach between the Tolt River Bridge and Neal Road (RM 24-33). Purple loosestrife is listed as a Class B weed; this means that it is abundant in some areas of Washington State, and controlling the spread of this species is required by law (King County WLRD, 2002a).

Native shrub species that were present included willow, snowberry (*Symphoricarpos albus*), salmonberry (*Rubus spectabilis*), red osier dogwood (*Cornus stolonifera*), Oregon grape (*Berberis nervosa*), elderberry (*Sambucus spp.*), and Indian plum (*Oemleria cerasiformis*). Bracken ferns (*Pteridium aquilinum*), sword ferns (*Polystichum munitum*), and lady ferns (*Athyrium filix-femina*) were also present. Stands of native riparian vegetation were typically composed of several species whereas stands of nonnative shrubs were usually monocultures.

Most of the riparian trees were deciduous, with red alder, vine maple, and black cottonwood found most frequently. Only three areas had more than 30% conifers, i.e., RM 22.4-22.5 on the LB, 36.3-36.5 on the LB, and RM 36.4-36.7 on the RB. Conifers were 5% to 30% of the trees at the following locations: RM 11.5-11.7 on the RB, 18.4-18.6 on the RB, 20.8-21.2 on the LB, 22.5-22.9 on the LB, 24.9-25 on the LB, 26.2-26.3 on the RB, 33.9-34 on the RB, 35.7-36.2 on the RB, 36.4-36.5 on the RB, and 36.7-38 on both banks. Coniferous species included western redcedar, Sitka spruce, grand fir (*Abies spp.*), and western hemlock (*Tsuga heterophylla*).
